1. INTRODUCTION

4. CASE STUDIES OF WHEN INTERFERENCE HAS TAKEN PLACE

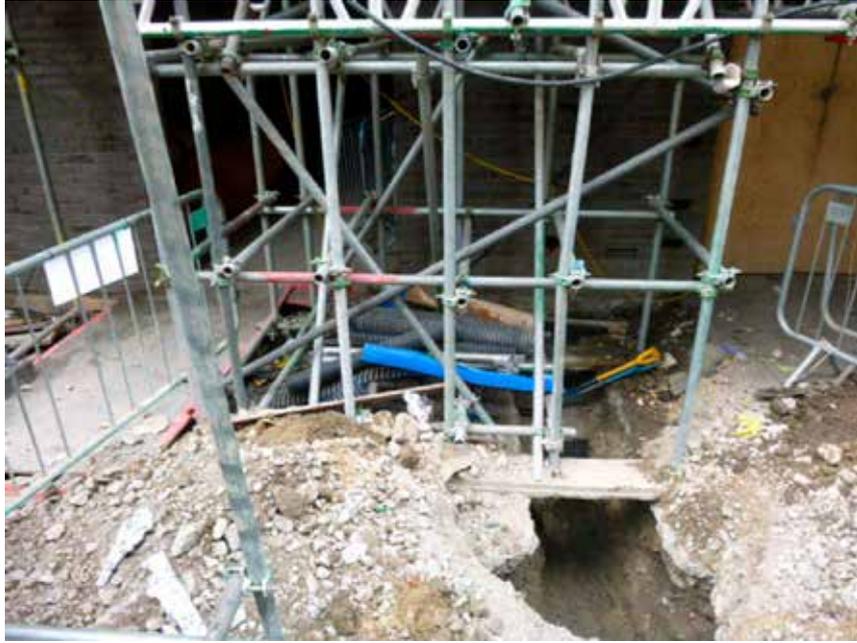
Case Study 1

Here is an excavation undermining a scaffold tower, which was supporting a 12m span of a beam section with 19 lifts erected above beam level, which had the potential to cause a scaffold collapse.

When the inspector asked the ground workers what they were doing they answered, “it’s ok we will be back filling the excavation in a couple of hours”. If you look closely at the leg above the excavation you can see where it has been hit and bent with the bucket of the machine whilst carrying out the dig.

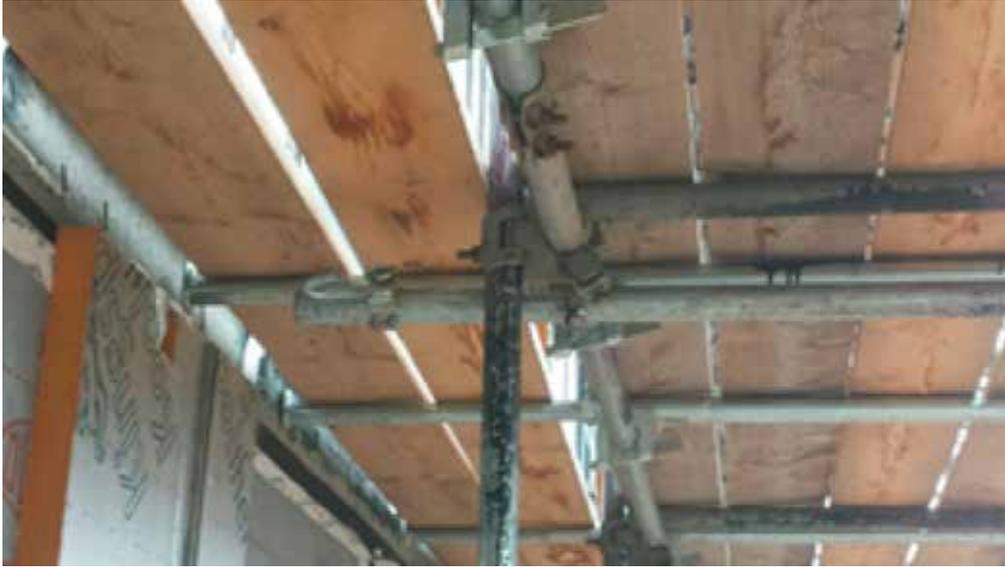
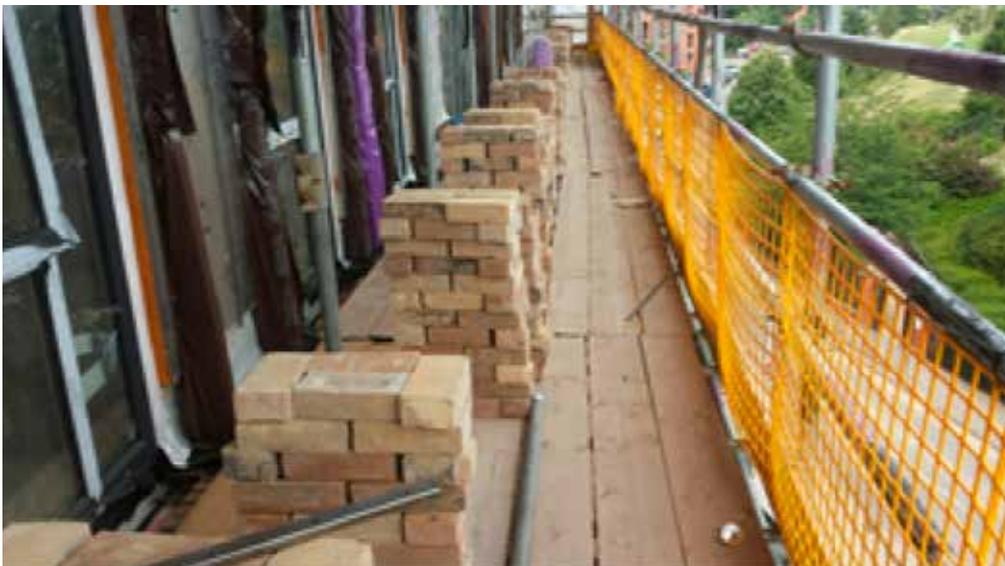
Case Study 2

Ties removed from scaffold by 3rd party contractors.

This was a 13 lift high scaffold on a high-rise apartment development in the West Midlands. Over 50 ties were found to be missing, leaving 8 lifts unsupported and at significant risk of collapse due to instability. The working lifts were fully loaded with masonry and two of the elevations had been clad with solid plastic scaffolding sheeting (monarflex type). Fortunately these hazards were identified and remedial actions taken to prevent a collapse, and the imminent danger averted.

Note: Overloading a scaffold – especially on the inside boards – is also an unauthorised modification.

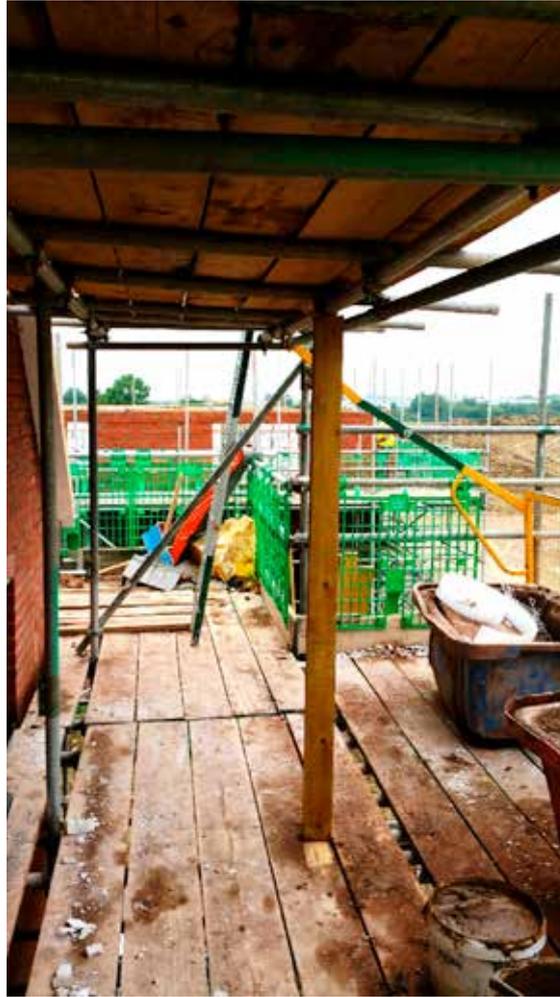
Case Study 3

A 3rd party had removed an entire standard that was restricting access from a loading bay and replaced it with a piece of 4 x 2 timber to prop up the deflecting lift above!

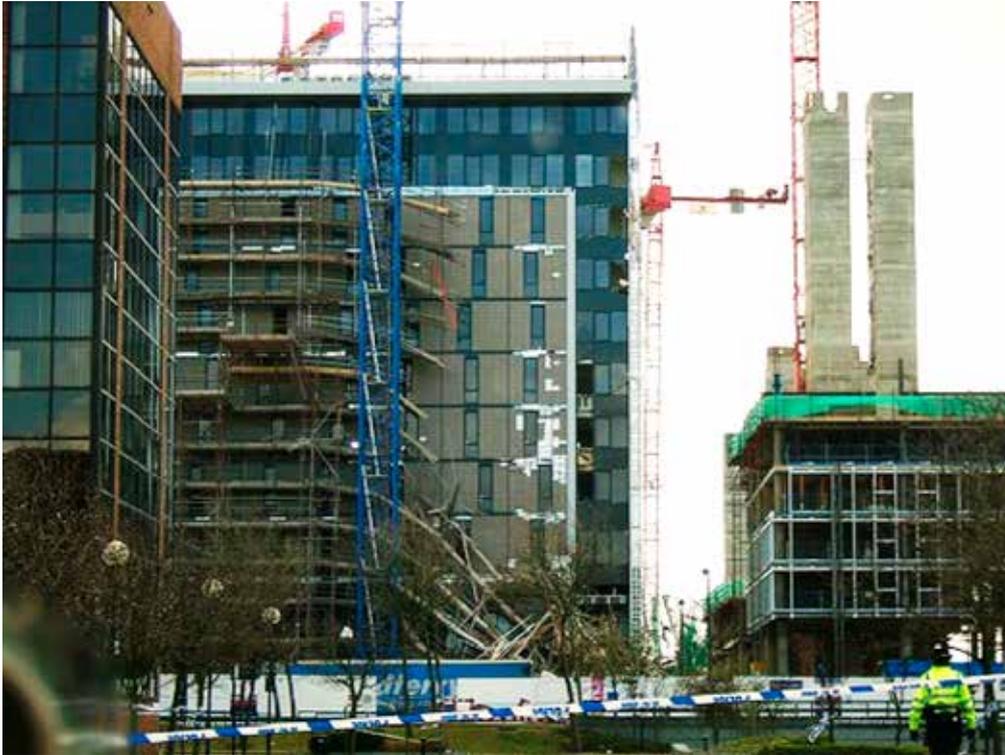
Case Study 4

An independent tied perimeter scaffold collapsed at a construction site in Milton Keynes. This occurred because the scaffold had been altered several times reducing its structural stability. Platforms were also overloaded and the combination caused it to fail. Three workers who were on the scaffold sustained multiple injuries. Sadly, one worker died 3 days later in hospital.
