1. INTRODUCTION OF SAFE STRUCTURES

2. HOW TO IDENTIFY UNAUTHORISED MODIFICATIONS

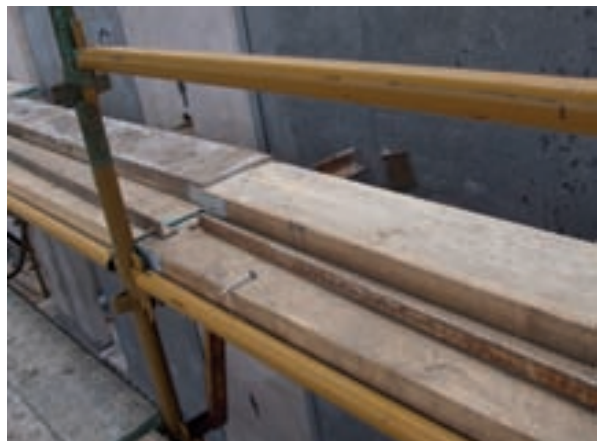
Removal of inside boards by other trades

- Check that toeboards have not been removed, or displaced.
- Check that any scaffold boards have not been removed, displaced or damaged (e.g. disc cutter marks).
- Check that transoms are suitably placed to support the boards and that the maximum support span identified on the board end plate has not been exceeded.
- Check that scaffold ties have not been removed.
- Check that any bracing is not missing.
- Check that any brickguards and/or netting, where fitted, are still in place.
- Check that the structure is not being overloaded.
- Check for any other signs of unauthorised interference. If found, report them to the scaffold contractor immediately.

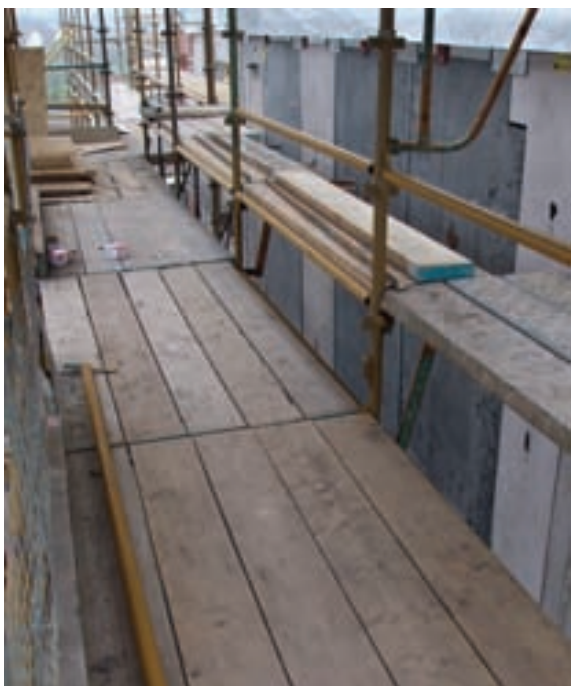
Removal of guardrails by other trades

- Check that the foundations have not been disturbed or undermined and the standards are on base plates and sole boards (as necessary).
- Check that guardrails are not missing and they are installed on every lift.

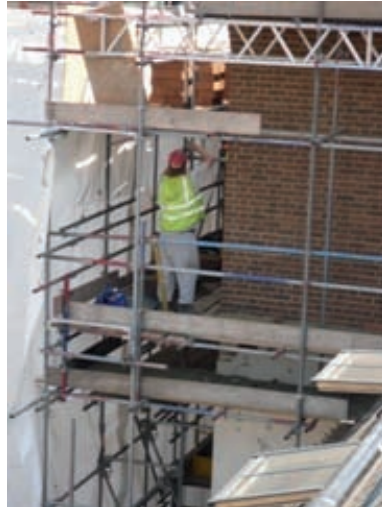
Bricklayer tampering with the structure

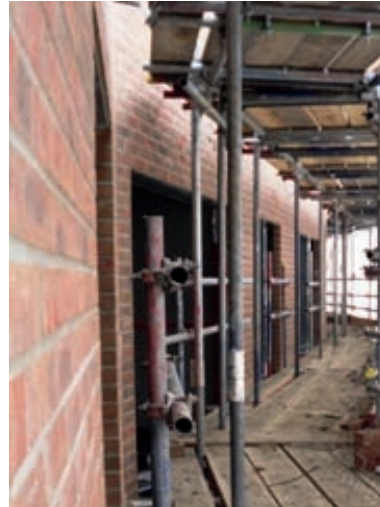
Stop-end removed by other trades
