# TG8:21

## Fire Damage

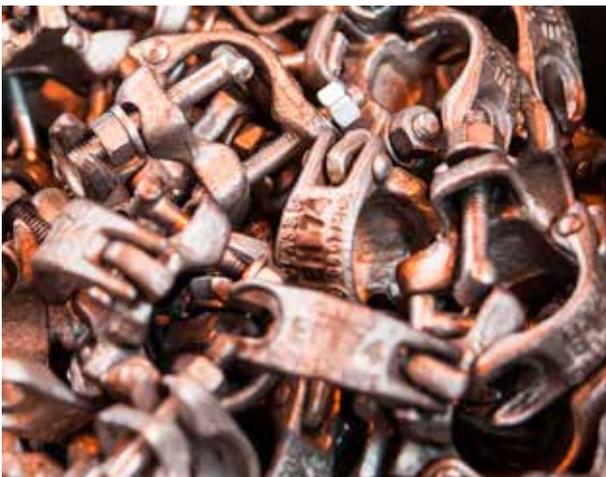
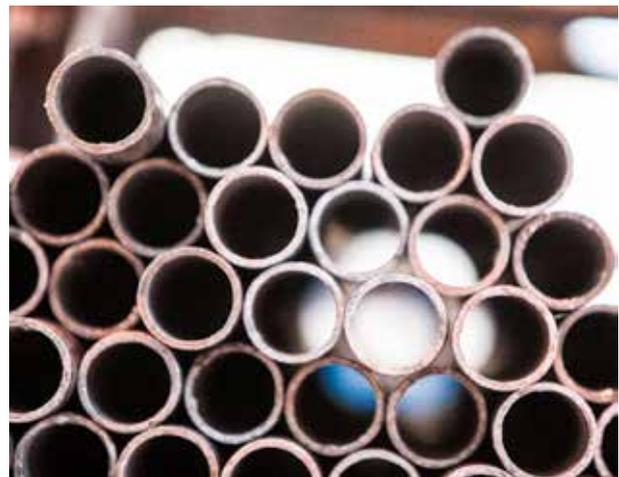
The integrity of welds on system scaffolding and other components is critical to the performance of the product and careful and extensive examination is required in this instance.

Whilst heat conductivity from a fire at a reasonable distance from the scaffold is unlikely to cause damage, if there is any doubt regarding the range of temperatures to which the equipment has been subjected and whether or not this could have affected the internal structure of the material, the equipment should not be re-used until specialist examinations by a competent metallurgist have been carried out. However, due to the complexity and high cost of conducting a comprehensive survey, in most cases it would be sensible for any equipment which has been directly affected by fire, to be responsibly disposed of/recycled.

Equipment which has been subjected to fire damage must be immediately segregated and securely quarantined to ensure that it is not reused.

All fire damaged equipment should be taken to a reputable scrap/recycling merchant, who should be made aware that it has been fire damaged and must be responsibly recycled to eliminate any possibility of it re-entering the marketplace and being reused for scaffolding purposes. This should form part of a legible documented process. As an additional precaution, tube and other equipment may be cut into small lengths to prevent it being re-used.
